17th Technical Training Series

William Heung P.E.

How to Get from Here to There

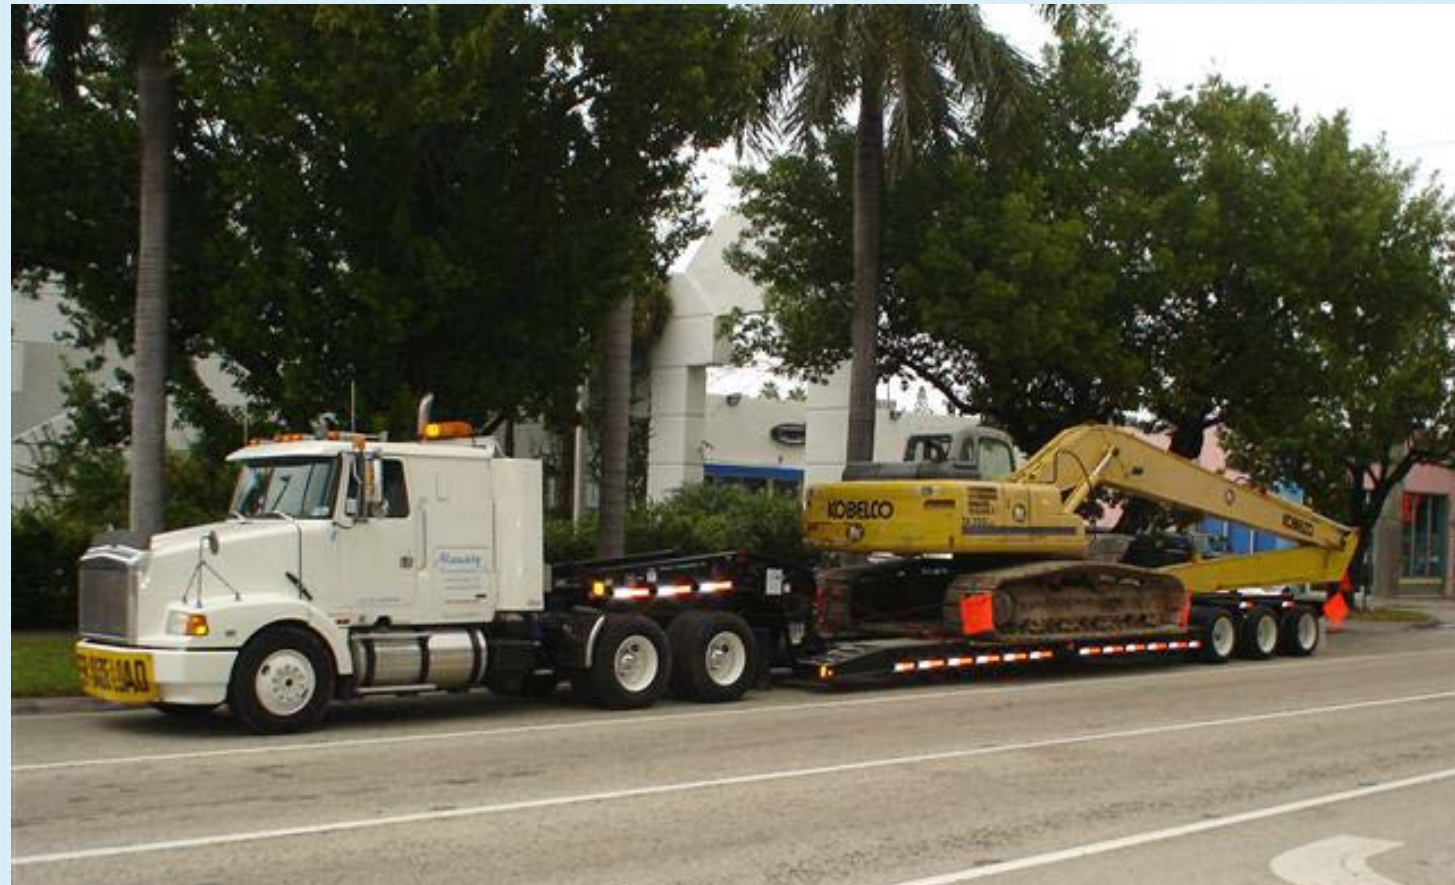
Equipment – Low Boy

Valley Fire – Approximately 50 crews completing 1 site every 1.5 to 2 days = 25 to 33 trips per day!

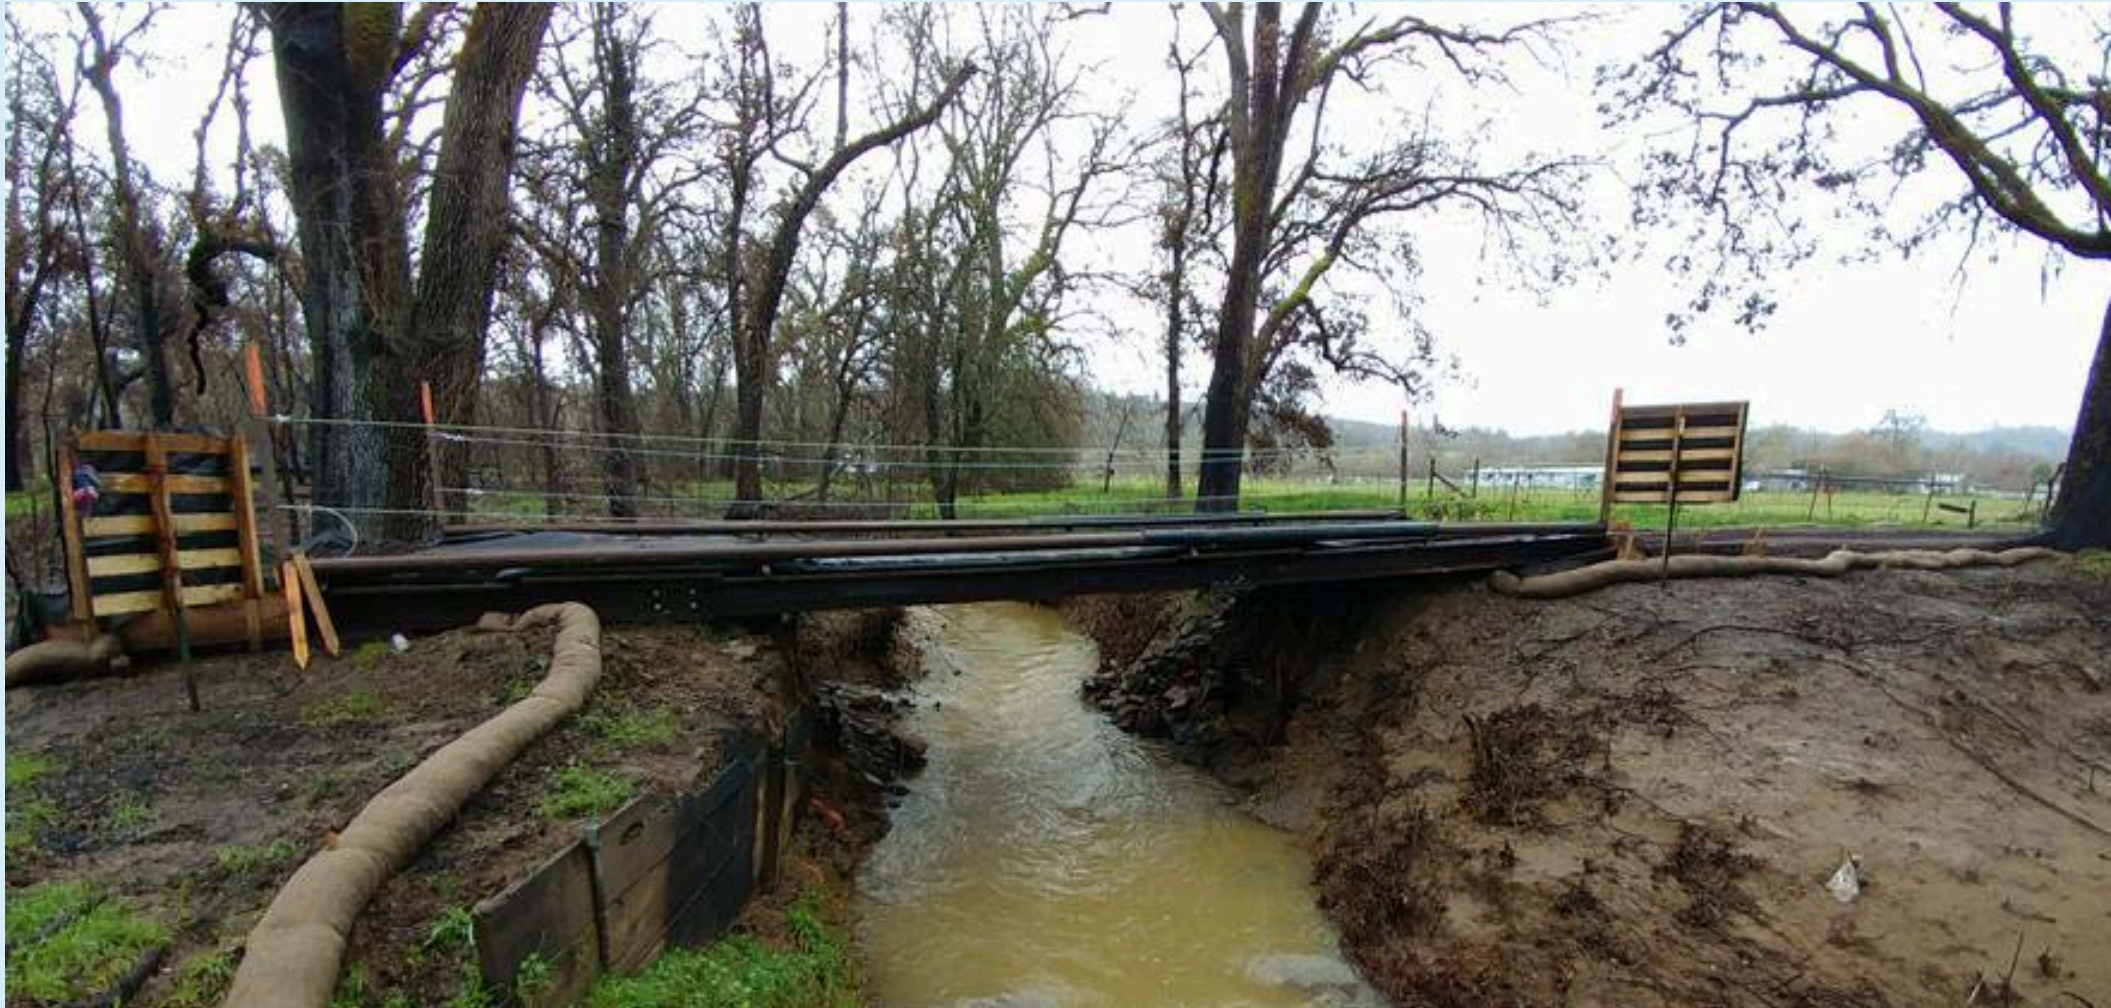
Specialized Equipment - Bridges

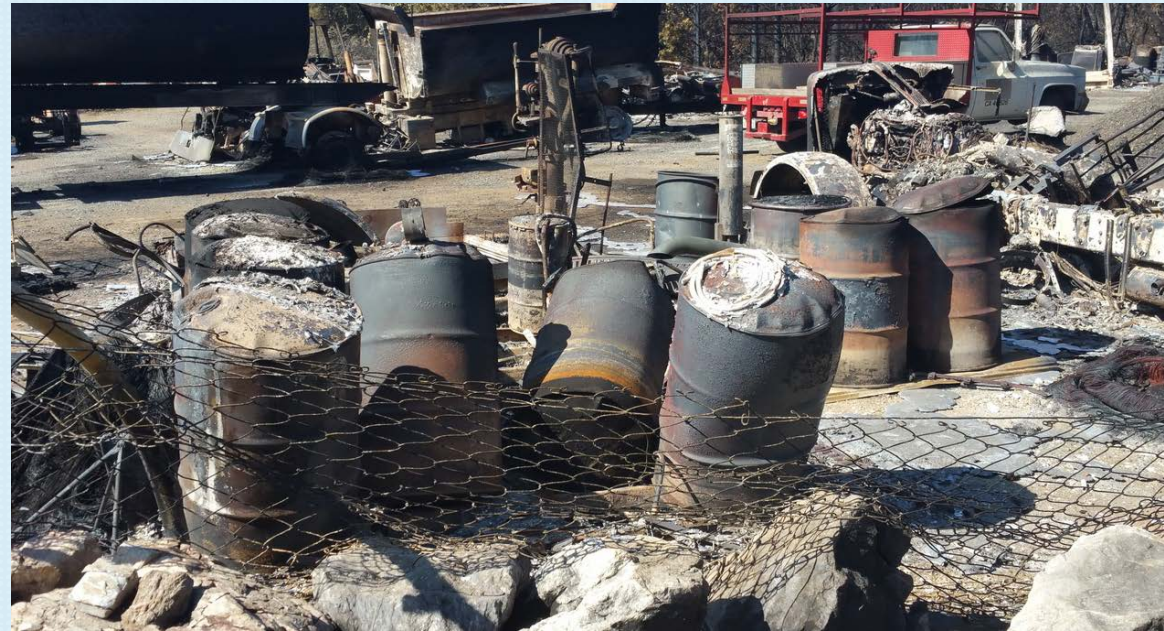
Debris Removal – Hazardous Materials

- Pressurized tanks
- Unexploded Ordnance
- Misc. Solvents
- E Waste
- Household Hazardous Waste

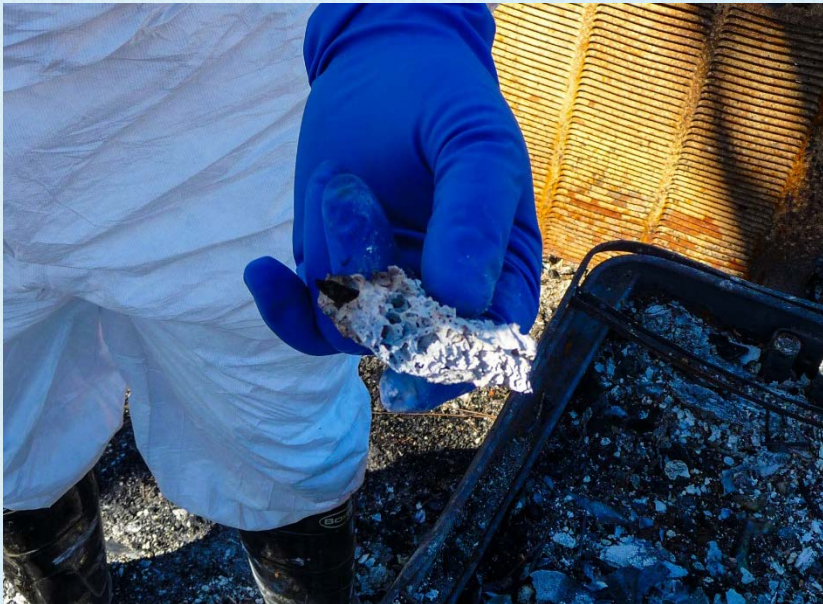
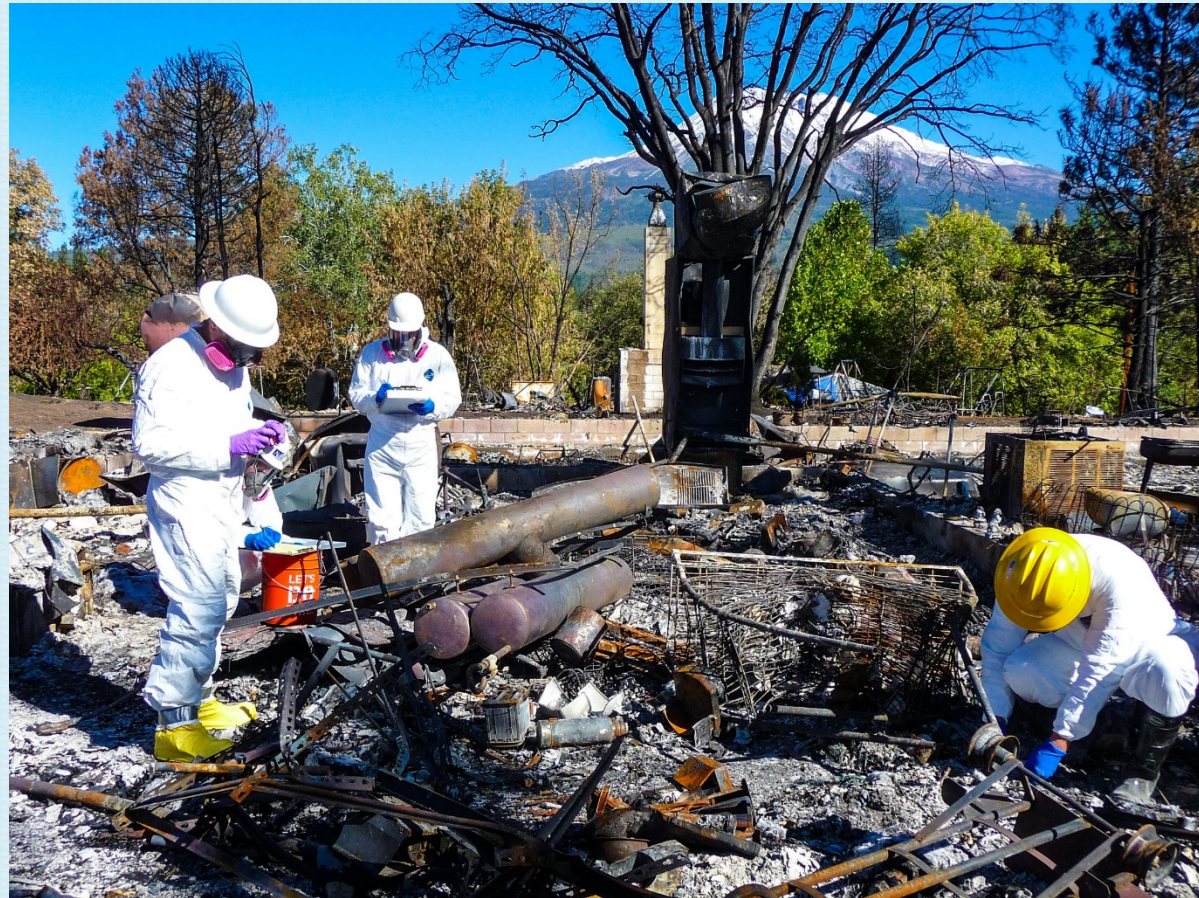
Debris Removal - Asbestos

- Hauled to Lined Class III Landfill, permitted to accept asbestos
 - Insulation
 - Pipes
 - Tiles
 - Chimney mortar

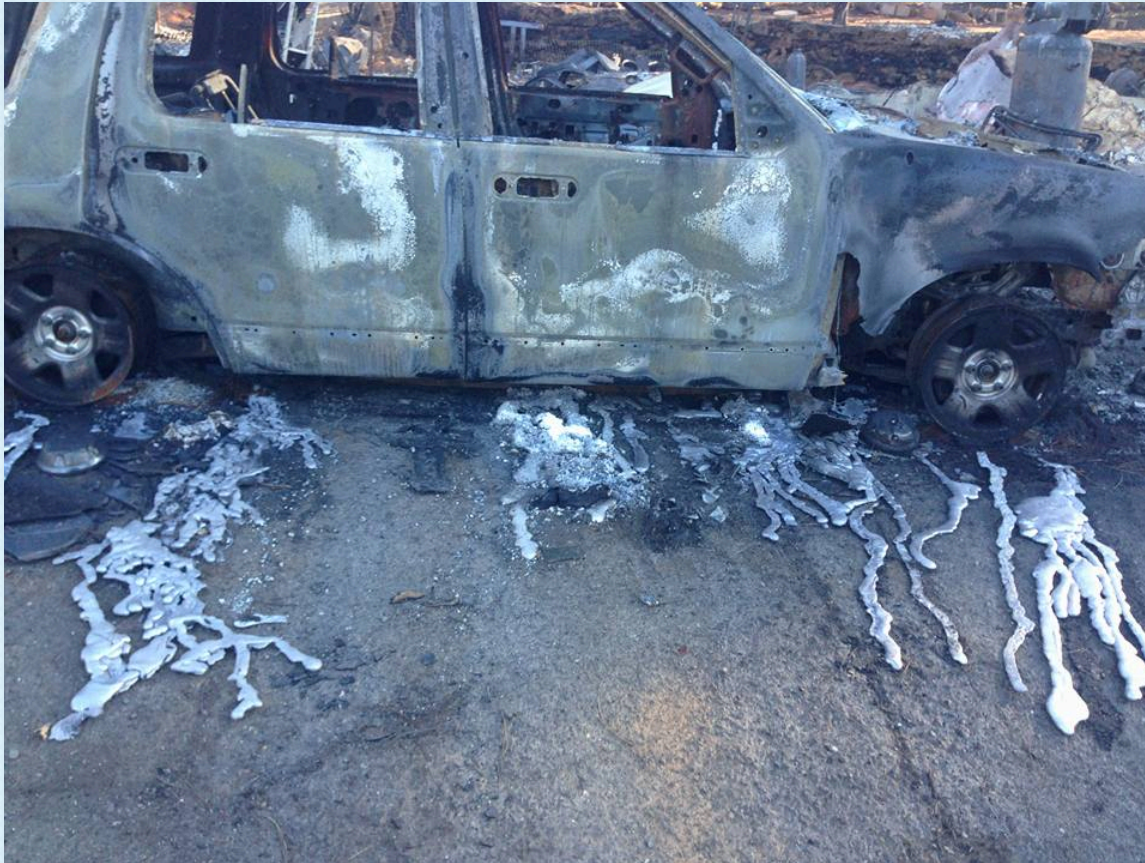
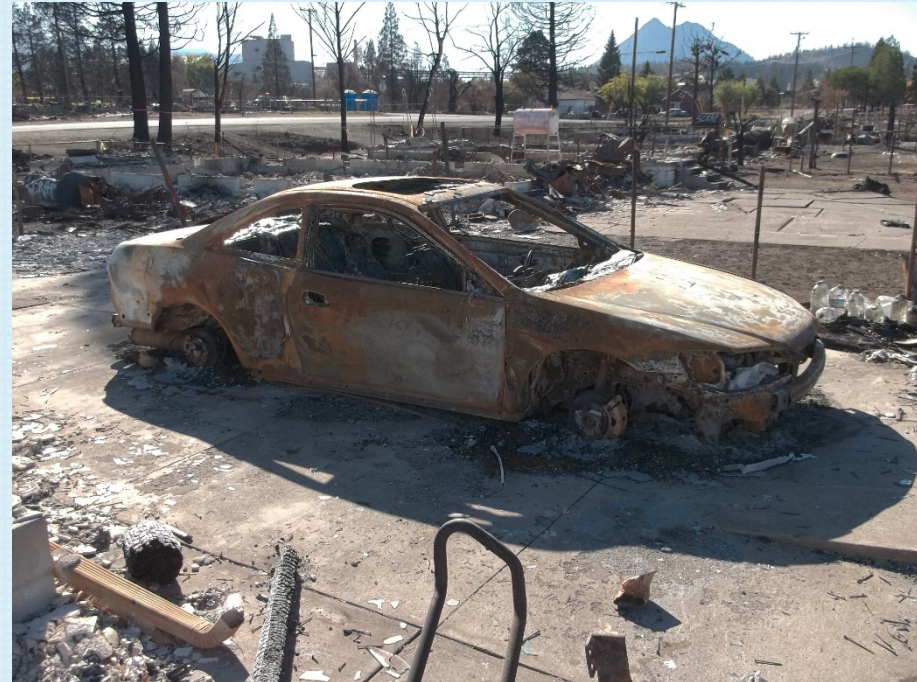
Debris Removal - Vehicles

- Recycled as metal after Insurance and DMV is contacted

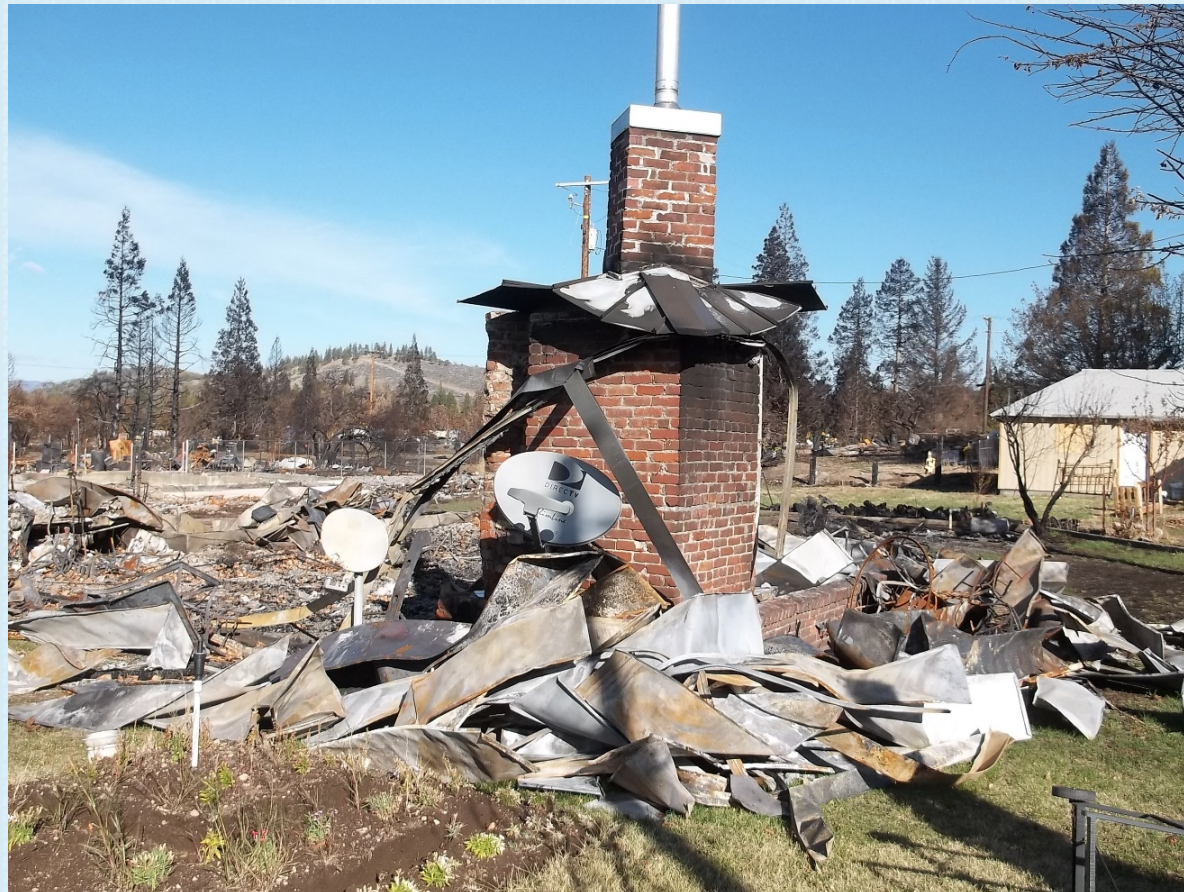
Debris Removal - Chimneys

- Disposed as ash/debris unless containing asbestos (new requirement)

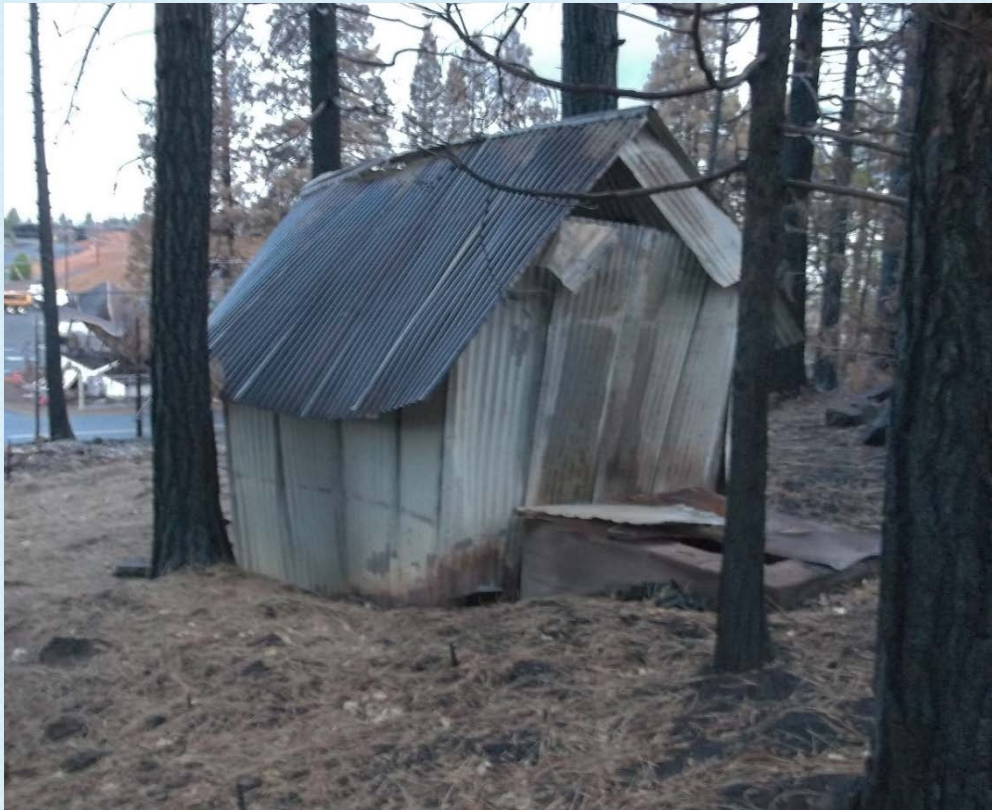
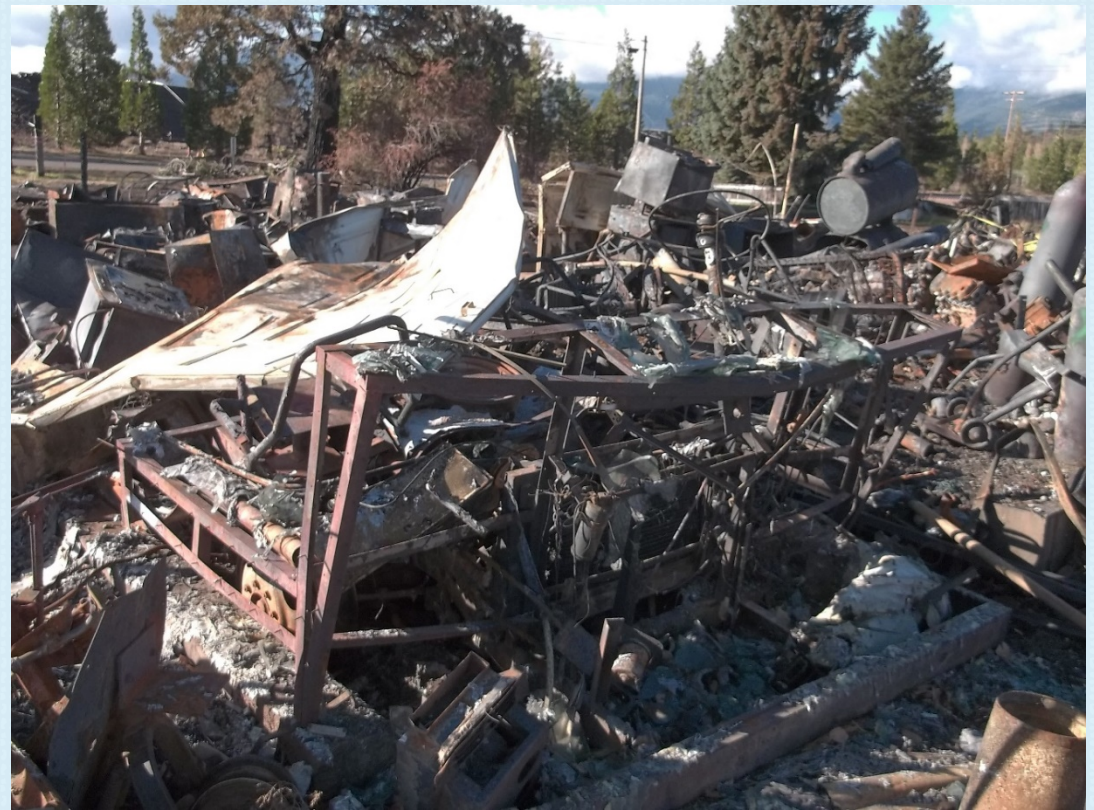
Debris Removal - Metal

- Recycled as scrap. Money gained goes to defray cost of project

- Garage doors
- Appliances
- Structural metal (I-Beams)
- Electrical equipment
- Trailers

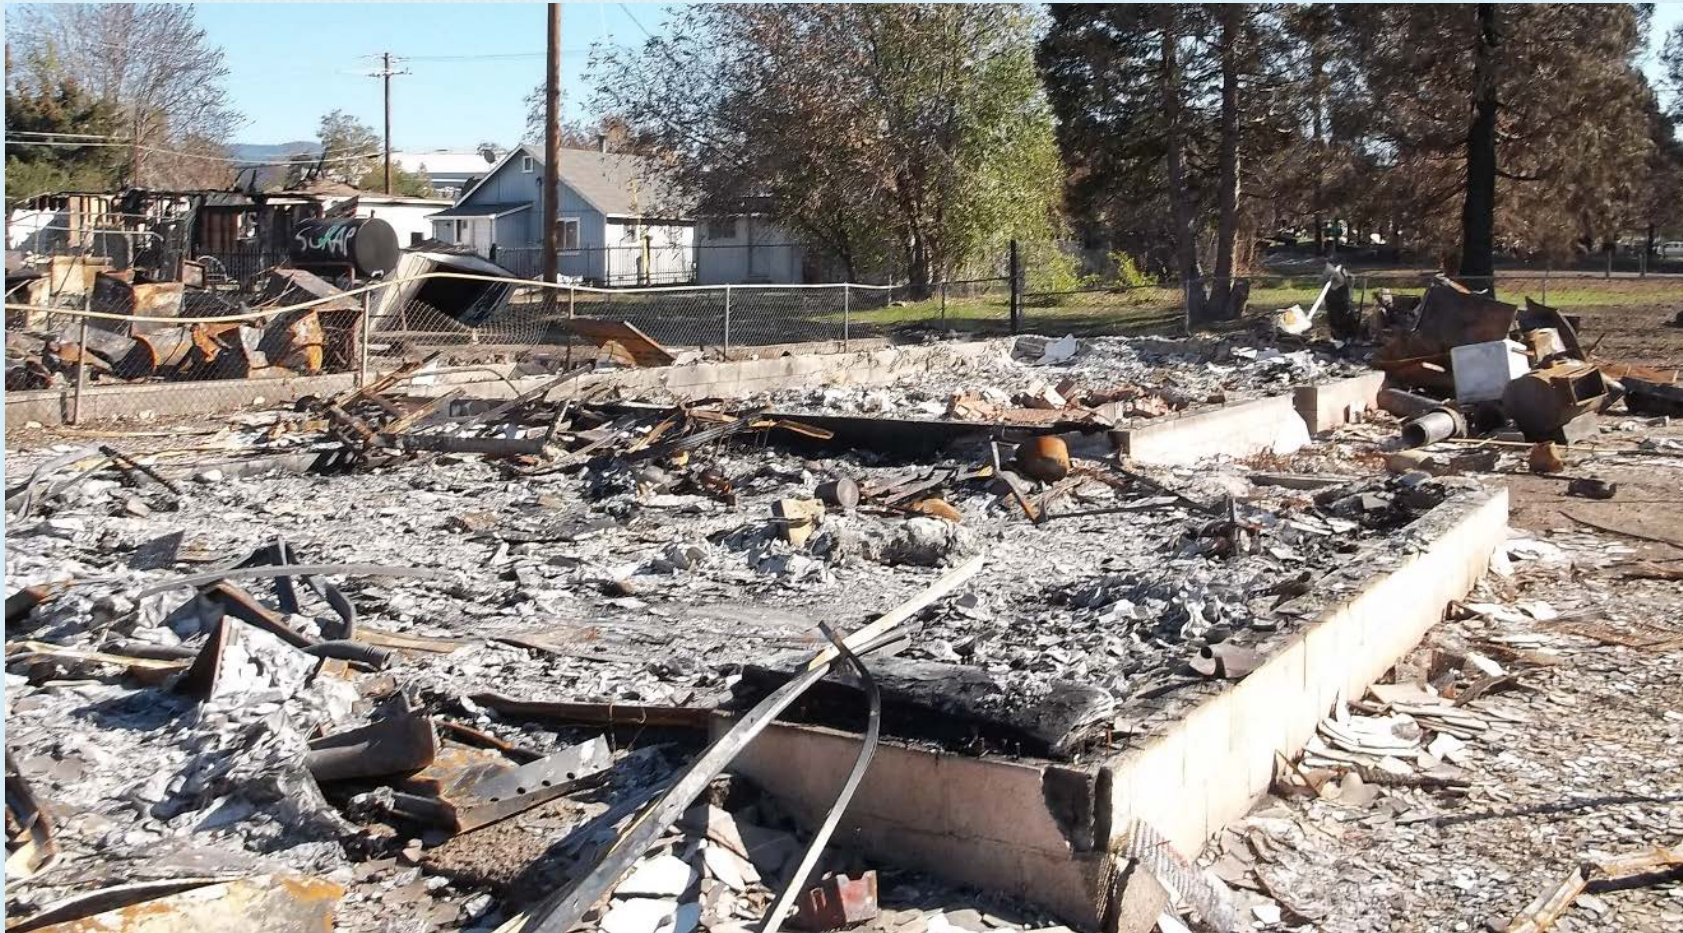
- Disposed as waste. “Burrito” wrapped in plastic

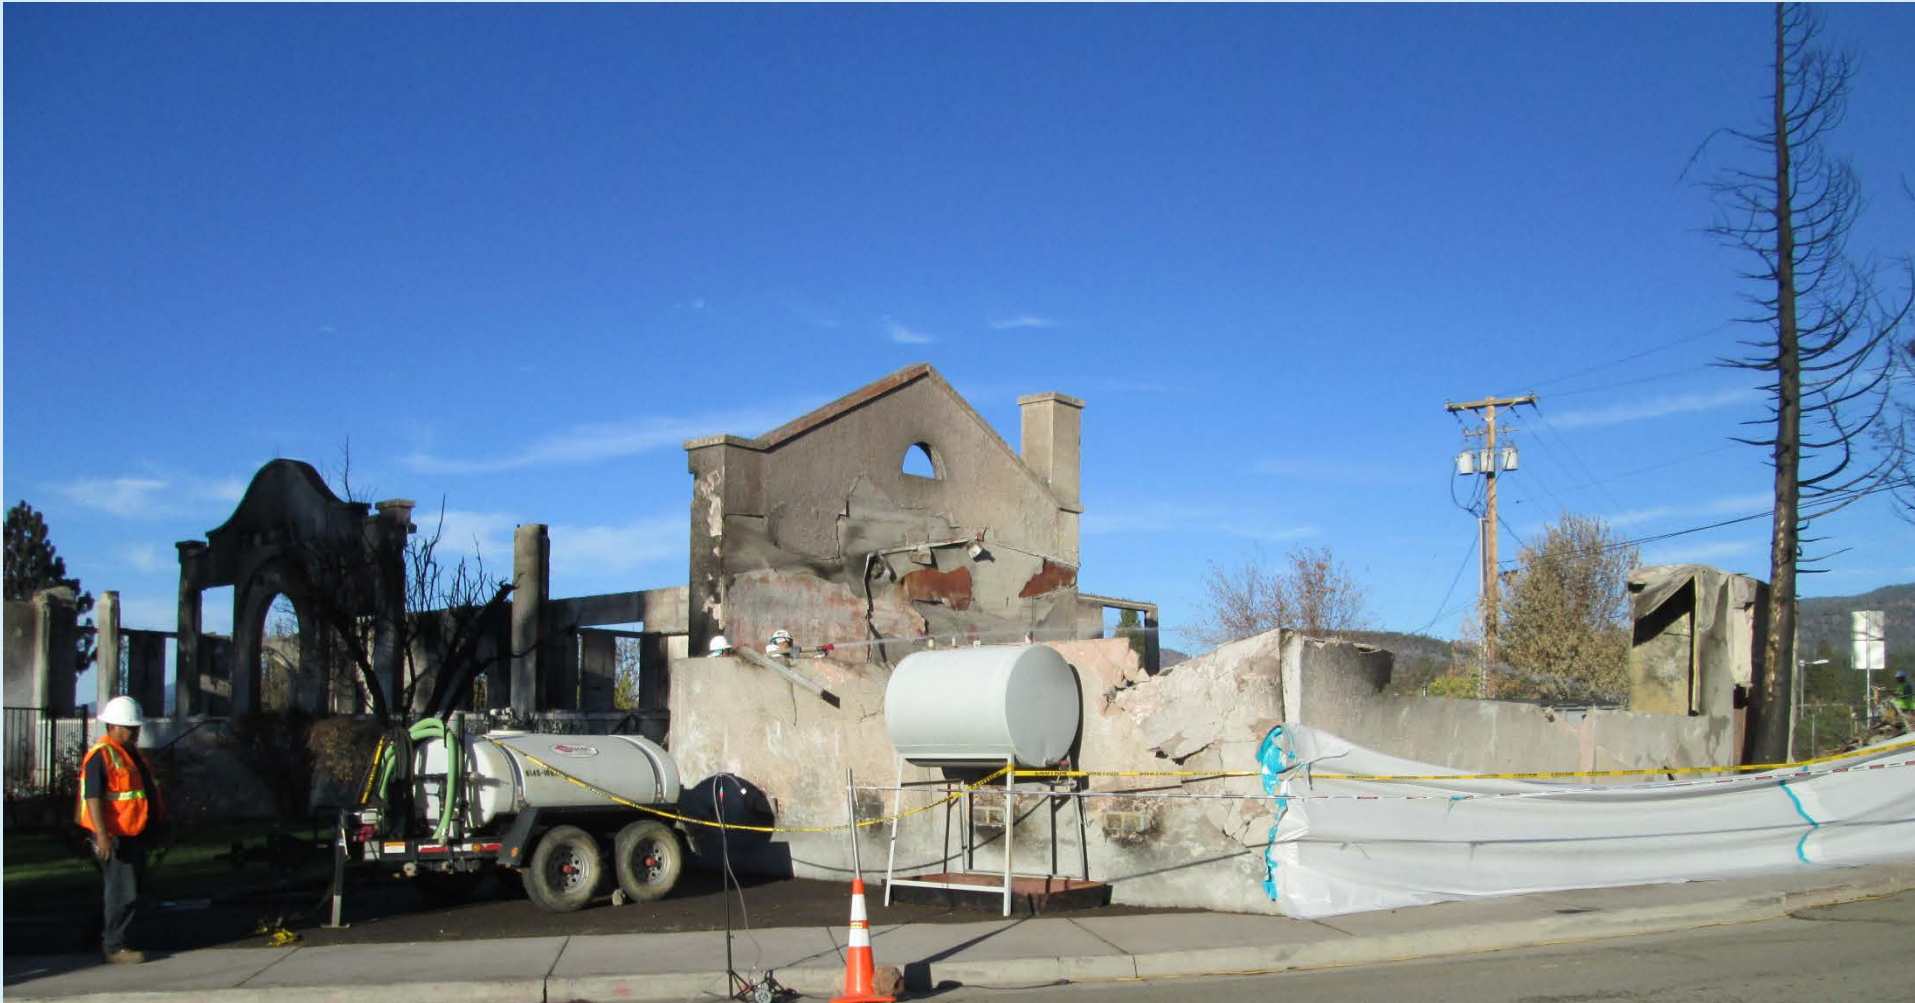
Debris Removal - Concrete

- Recycled if possible, if not goes out as waste

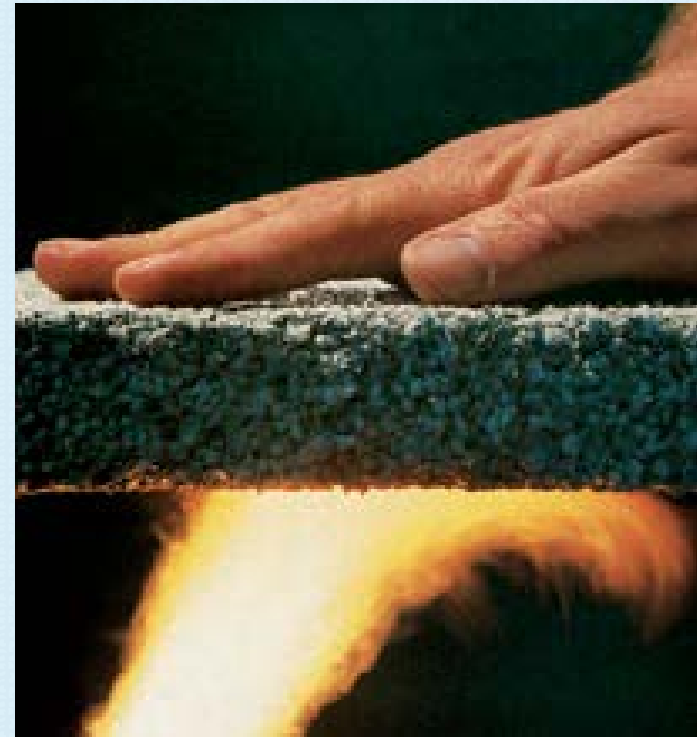
- Properties of Concrete
 - Inert to fire, durable, cheap
 - Conducts heat VERY slowly
 - Concrete exposed to heat for 1 hour:
 - Surface Temp = 600 °C
 - 1 inch below Surface = 300 °C
- Even at partial strength, concrete is very strong

- At 300 °C, Concrete is at 85% to 60% strength
- At 550 °C, Concrete is at 45% to 30% strength
- At 900 °C, aggregates pulverize and cement paste fragments, leaving gaps in the slab
- Average Wildfire temp: 800 °C, can reach up to 1200 °C
- Embers of homes keeps elevated temperatures for days
- Heat reduces bonding strength of rebar to concrete

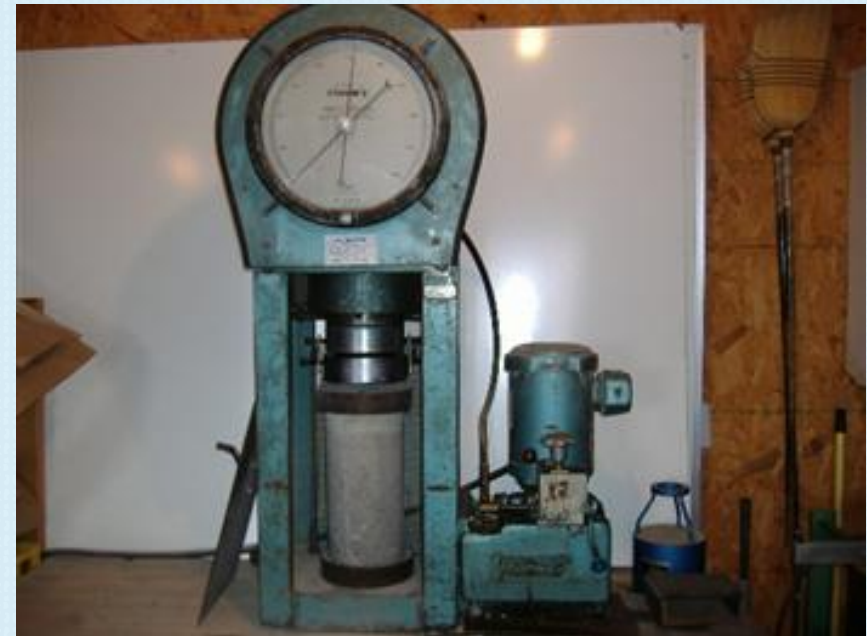
- Rebuilding on Damaged Foundation
 - Varies County by County
 - Core samples can be taken for strength testing
 - Compressive versus Sheer

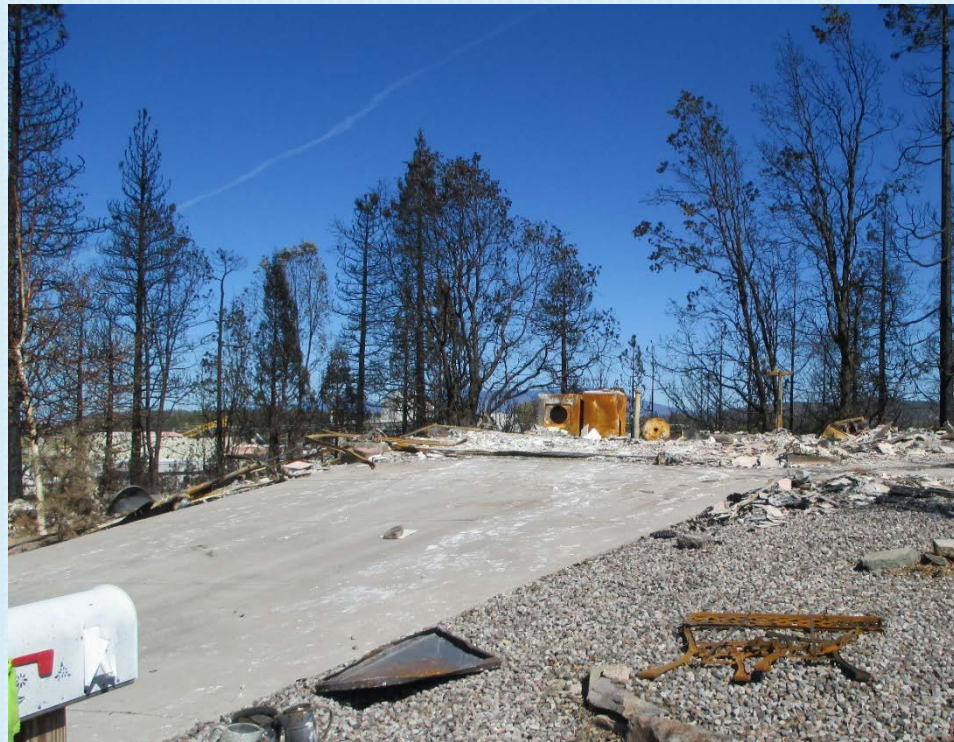
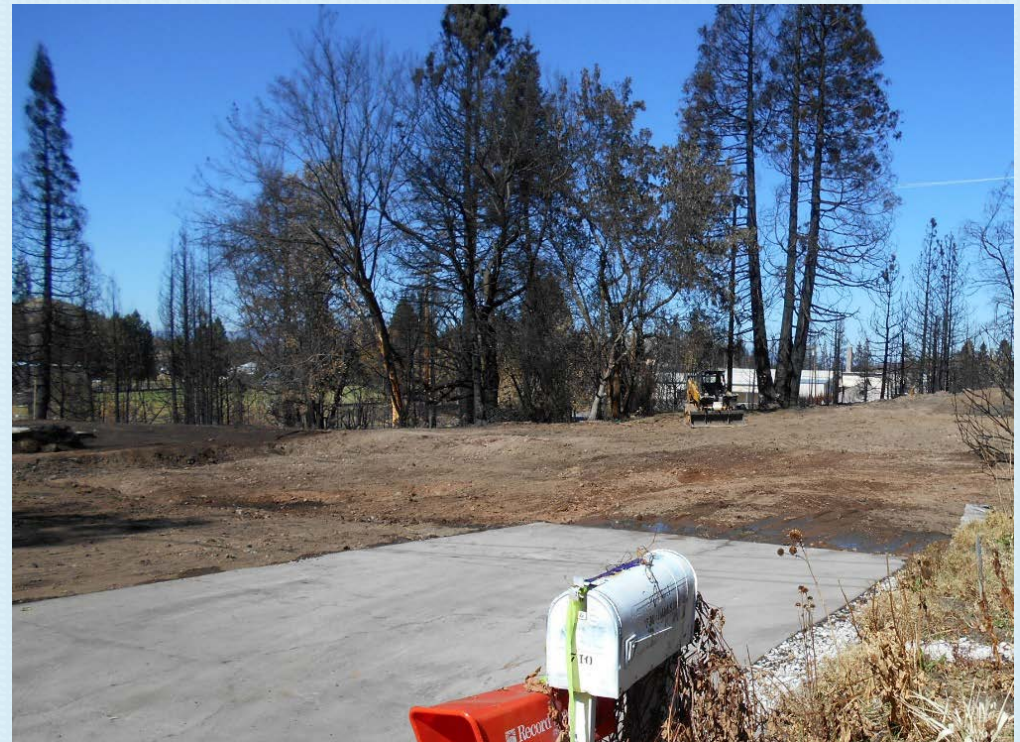
Lessons Learned: Concrete Slab Removal

- Rare instances concrete is left
 - Driveways
 - Well/pump houses

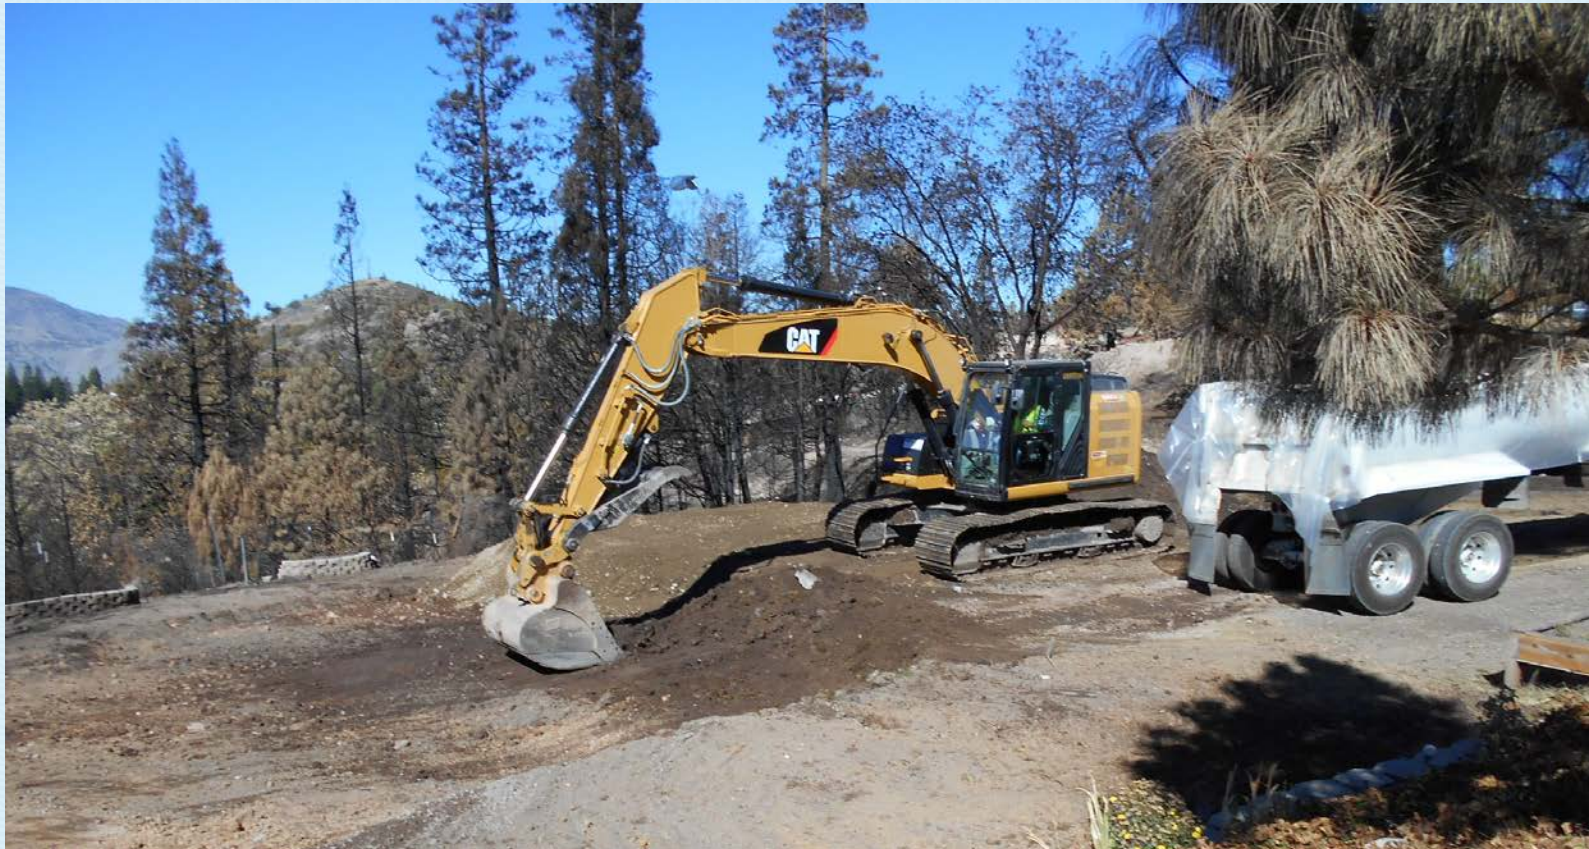
Debris Removal - Soil

- Soil – Used for ADC if possible (pending approval by Water Board, depending on soil characteristics), disposed as waste otherwise

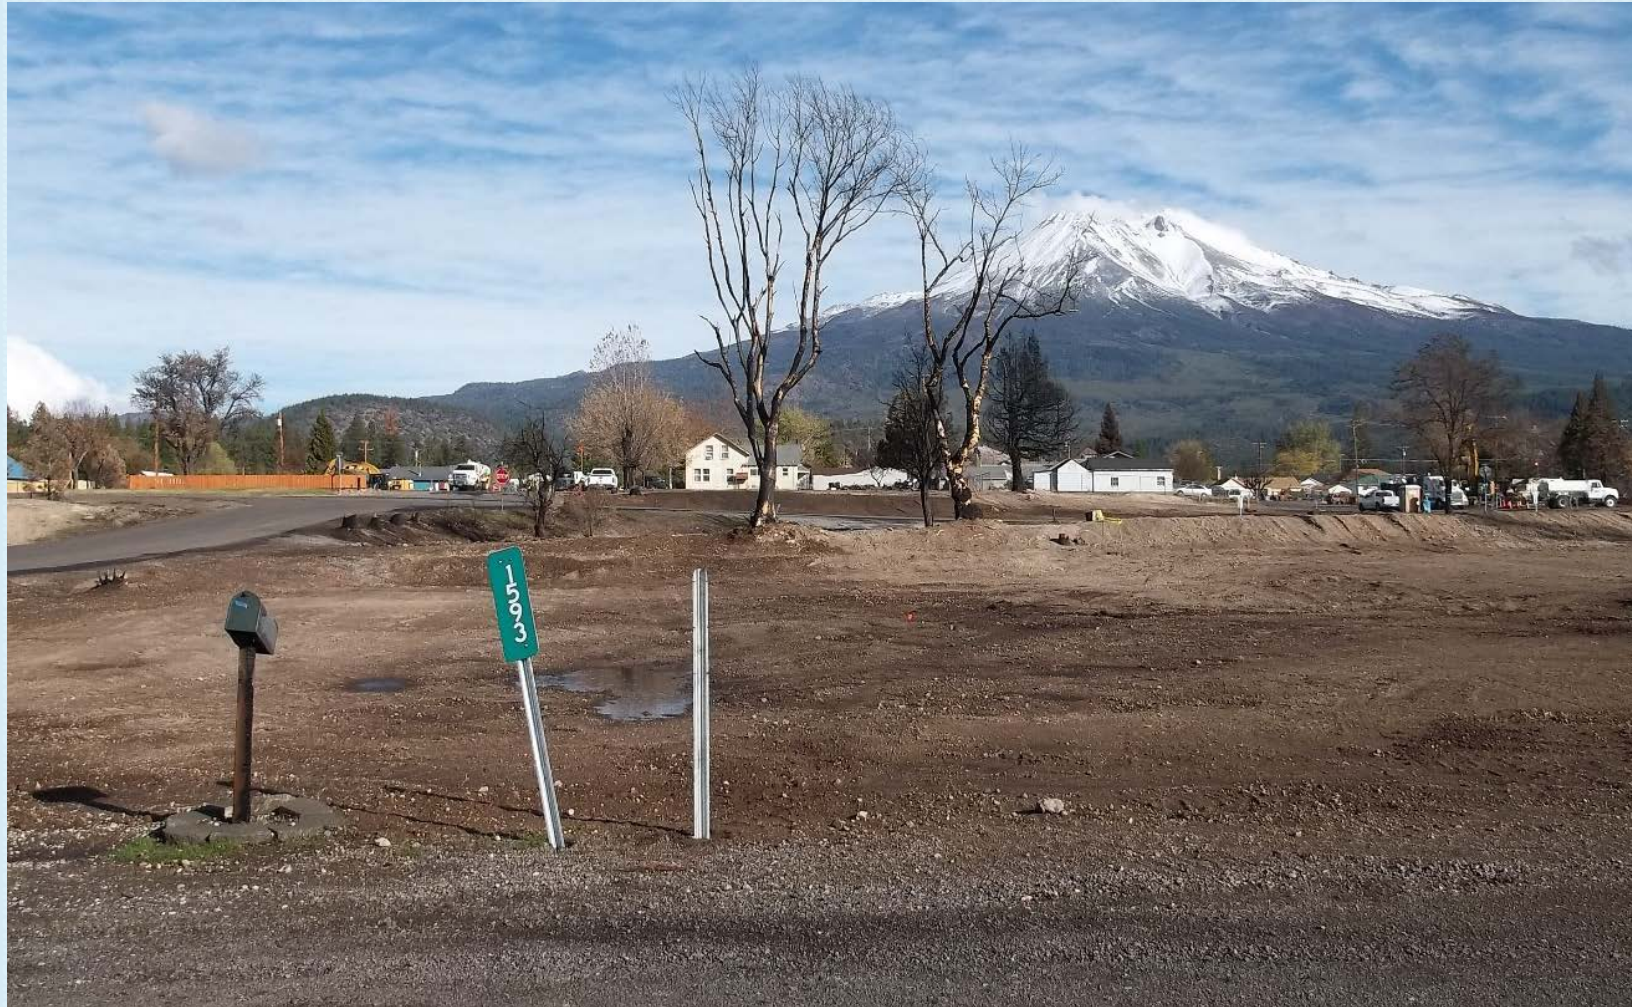
Soil Confirmation Sampling

- Samples locations and frequency are determined based on removal area and structures
- Collect samples and send to lab for analysis
- Compare soil results to cleanup goals
- If results exceed cleanup goals, another layer of soil will be removed for disposal and the site re-sampled
- If results are less than cleanup goals, debris removal is considered complete
